Cross section PR156A is located just upriver from PR156 and was established after the flood of 1978 when we thought PR156 had been washed away. The left bank is on the floodplain formed after the 1978 flood (Moody et al., 1999), which steps upward onto a Lightning-level terrace. The right bank is on the Lightning-level terrace (Moody and Meade, 2008). Section PR156A was resurveyed annually for 2 consecutive years 1979-1980, resurveyed in 1982, resurveyed annually during the 15 consecutive years 1984-1998. We made an abbreviated survey in 1999 when preparing to write the paper on floodplain ontogeny (Moody and others, 1999), and then conducted full surveys in 2011, 2012 and 2013.

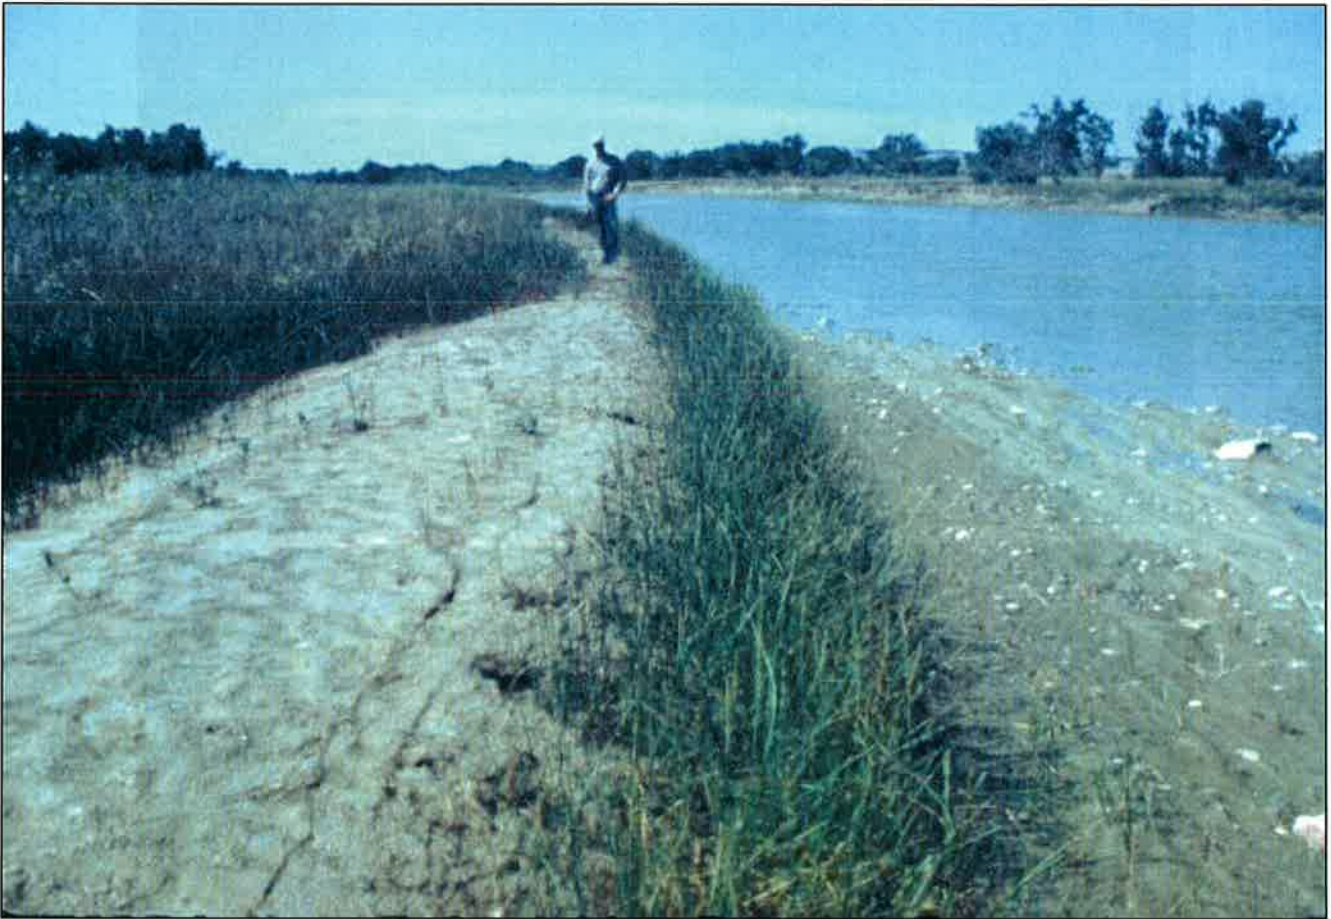
PR156A. **Top.** 20 August 1986. View upriver. J. Moody (~1.9 m tall) is standing on the section at station 63, on top of newly (1986) deposited berm of sand, 0.3-0.4 m thick. Compare to photo taken 30 September 2013 on 'new' bench at station 58 and below the level of this berm.

PR156A. **Top.** 30 September 2013. View upriver from right bank at station 58 on new bench. Compare to photo taken on 20 August 1986. **Bottom.** 30 September 2013. View downriver from right bank at station 58 on new bench (see plots in data file).

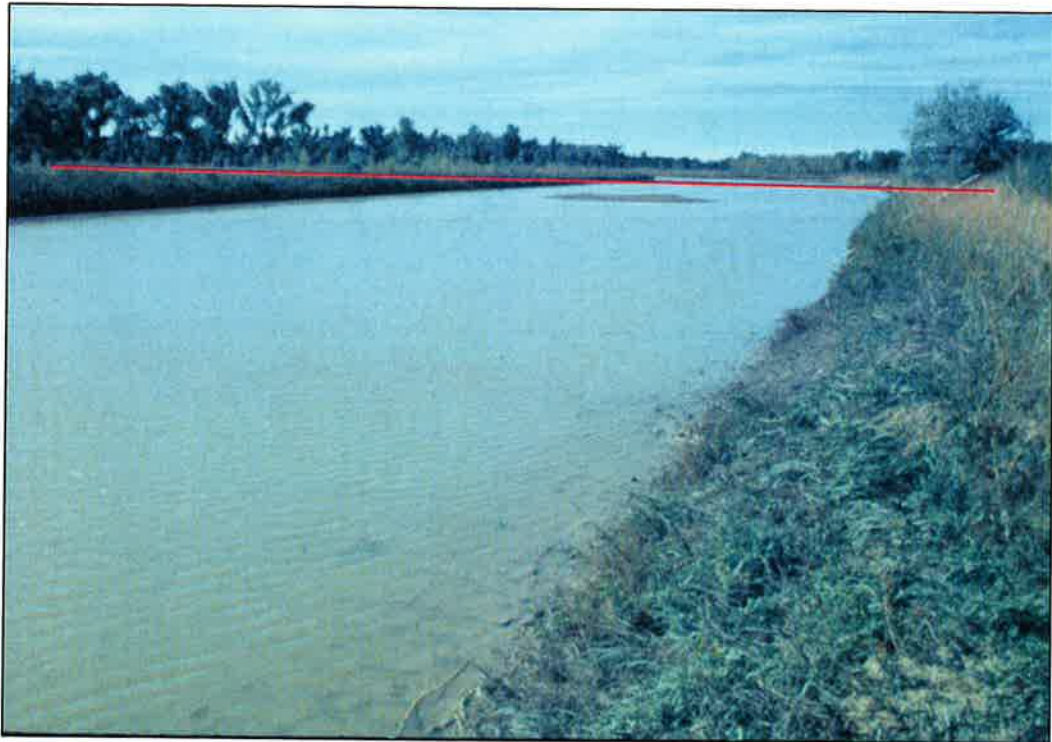
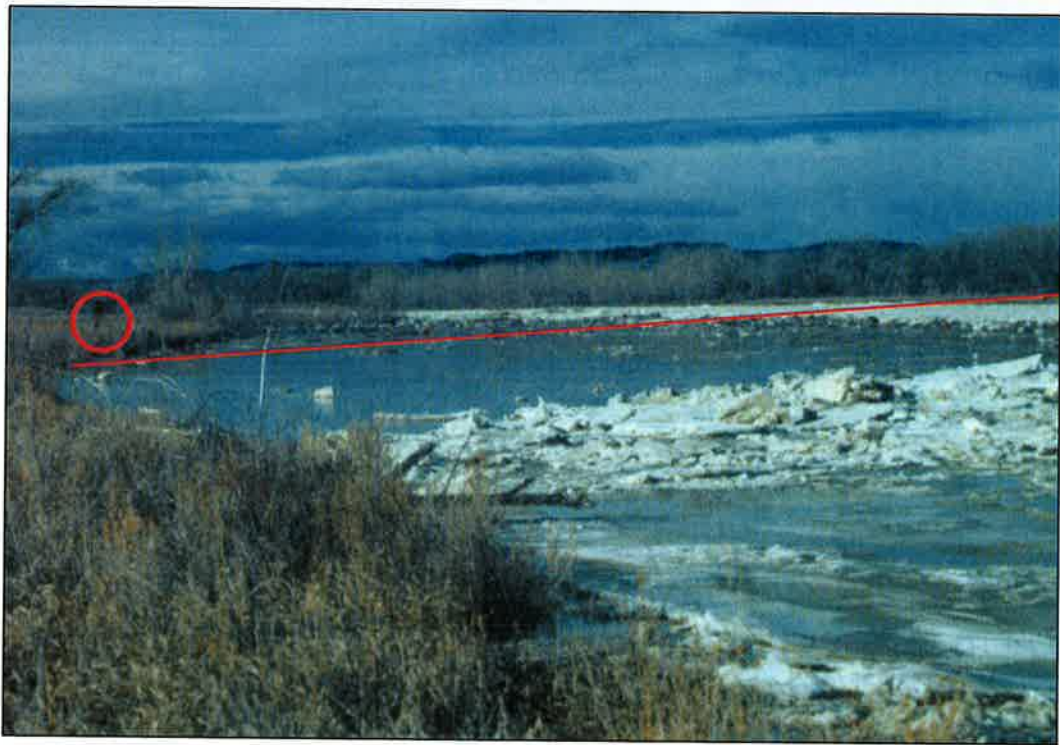
PR156A. **Top.** 22 September 1994. View upriver from left bank. **Bottom.** 11 March 1995. View upriver from left bank during ice-break-up flow. J. Moody (~1.9 m tall) in red circle is standing approximately 10 m upriver of line of section. Red line indicates the approximate line of section.

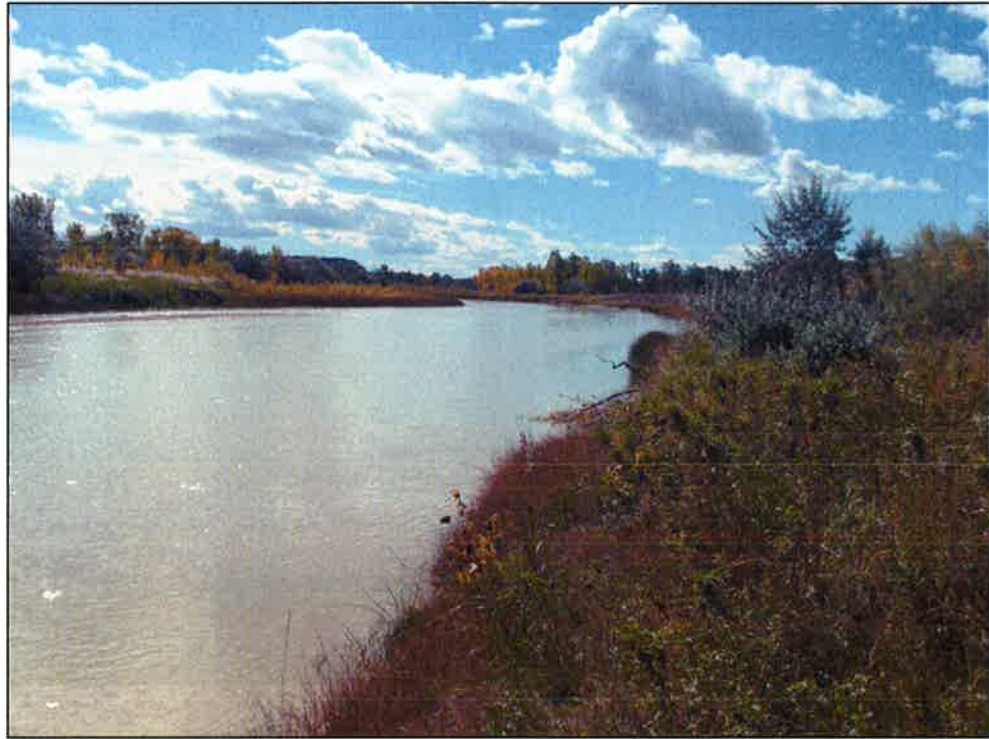
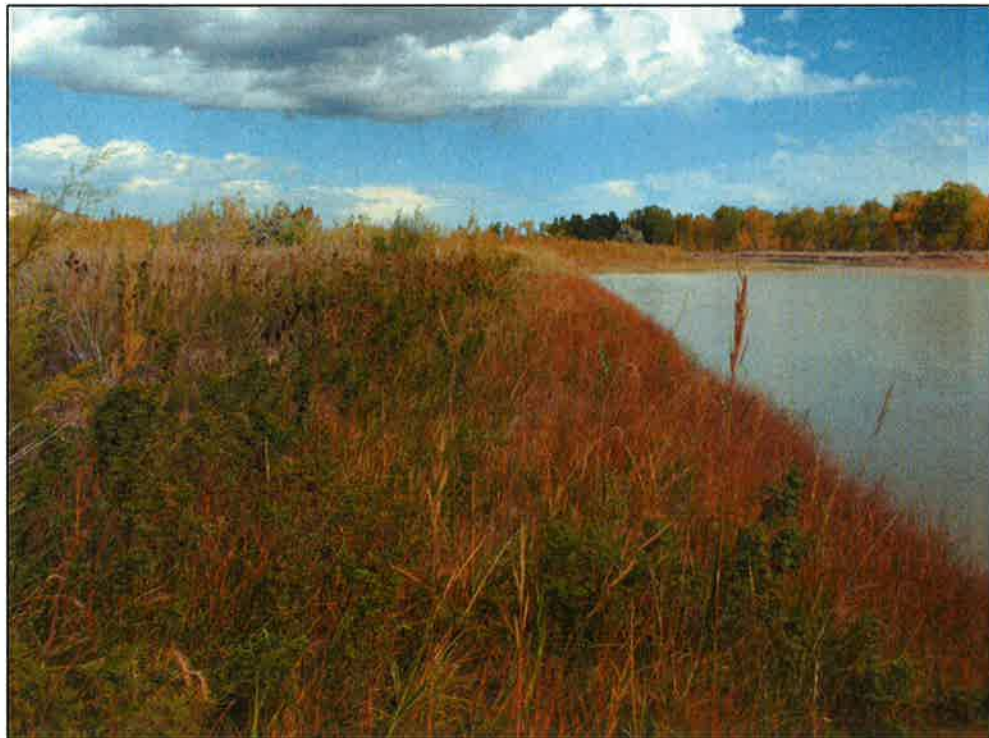
PR156A. **Top.** 30 September 2013. View upriver from left bank at station 10. **Bottom.** 30 September 2013. View downriver from left bank at station 10.

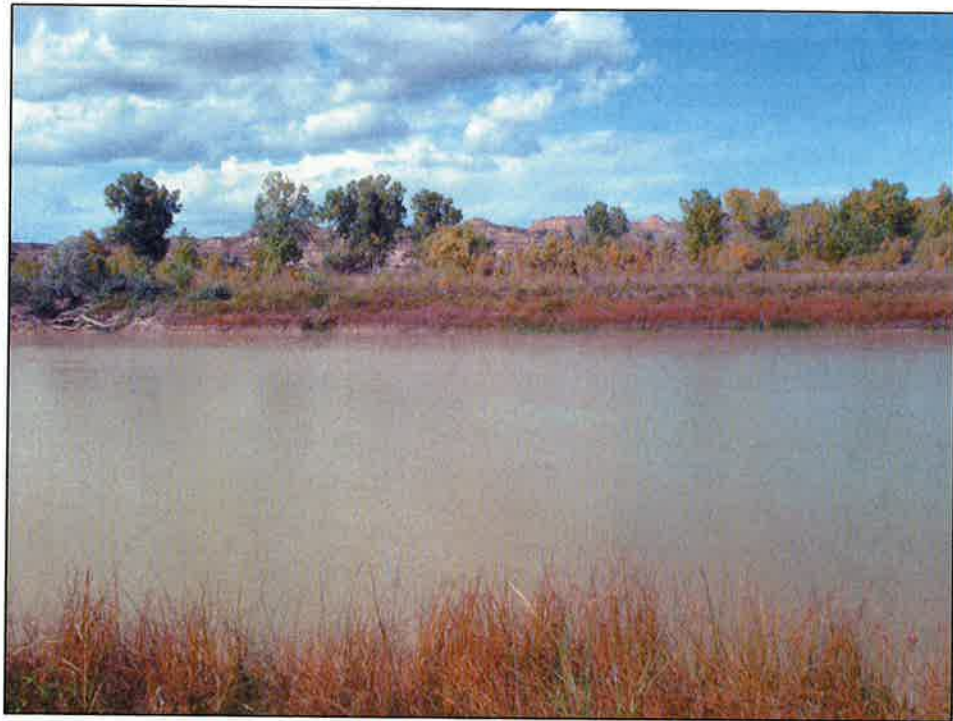
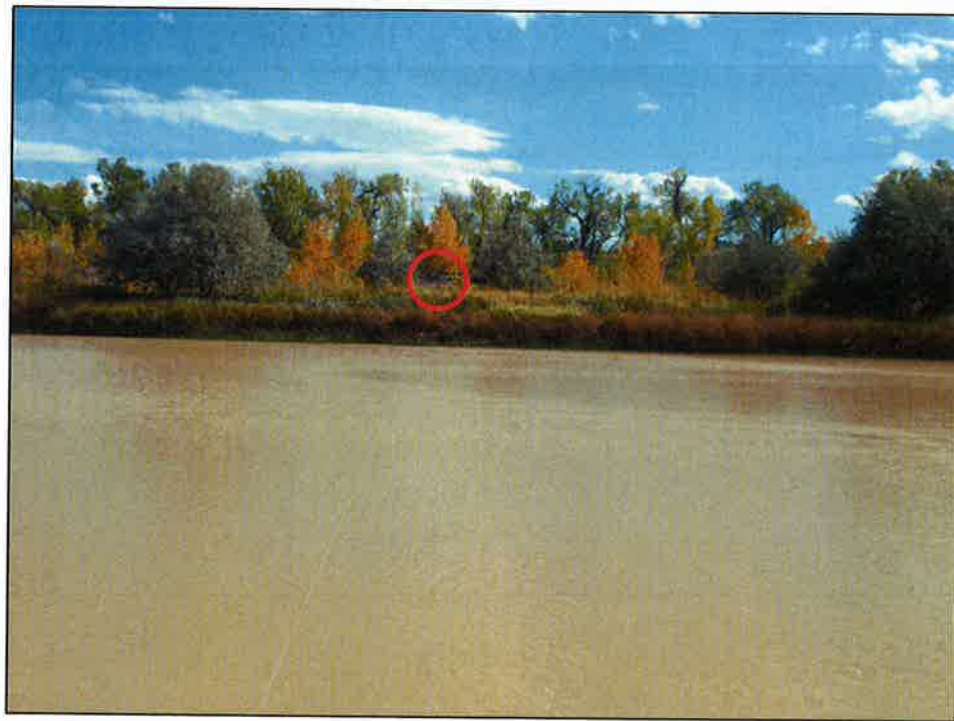
PR156A. **Top.** 30 September 2013. View of left bank from station 58 on right bank. **Bottom.** 30 September 2013. View of right bank from station 10 on left bank. Line of section goes between cottonwood tree with two trunks (inside red circle).
